Sanitary Sewer Evaluation Mission Hills Selected Sewers for Johnson County Wastewater

Subject: Mission Hills Selected Sewers SSES Final Report
GBA Project No. 10496.00

Johnson County Wastewater contracted George Butler Associates, Inc. to conduct a Sanitary Sewer System Evaluation of sewers owned by Kansas City, Missouri that are located within the City of Mission Hills. The project is intended to identify system defects that require repair.

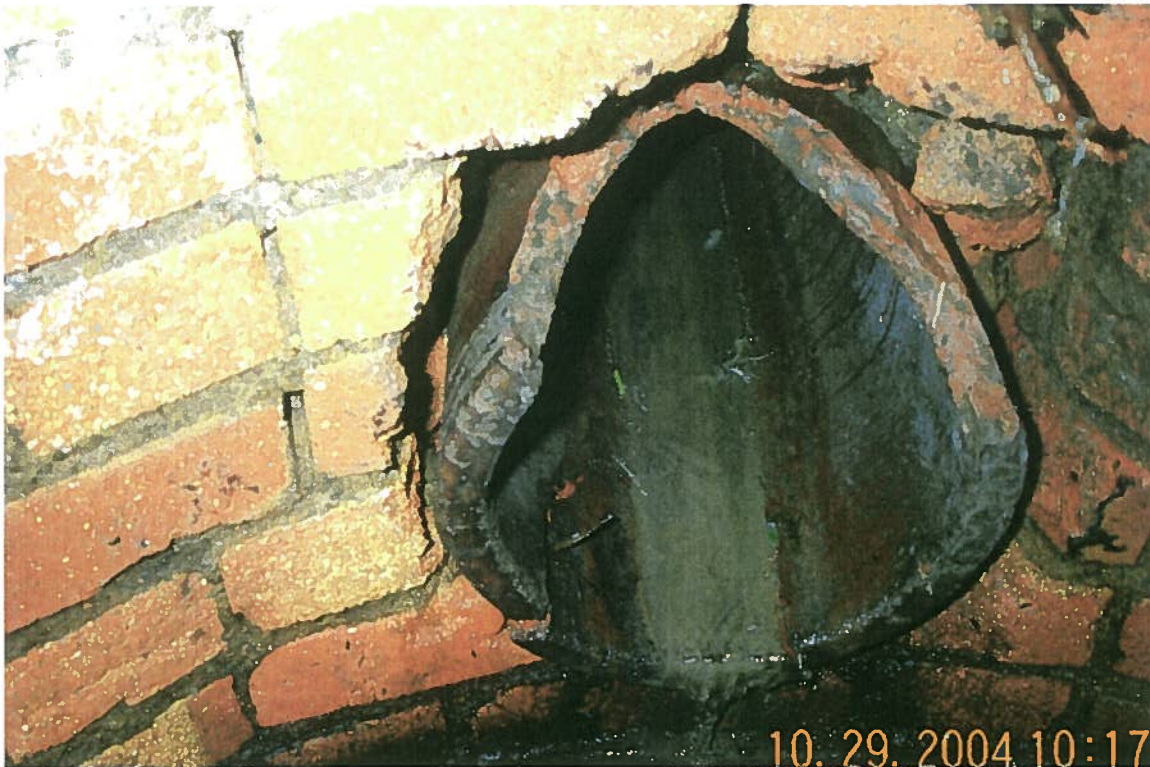
Manhole: 9-7

Defect: Pipe Seal

Description: Severe pipe seal defect. Heavy dyed-water entered around pipe during main line dyed water test upstream.

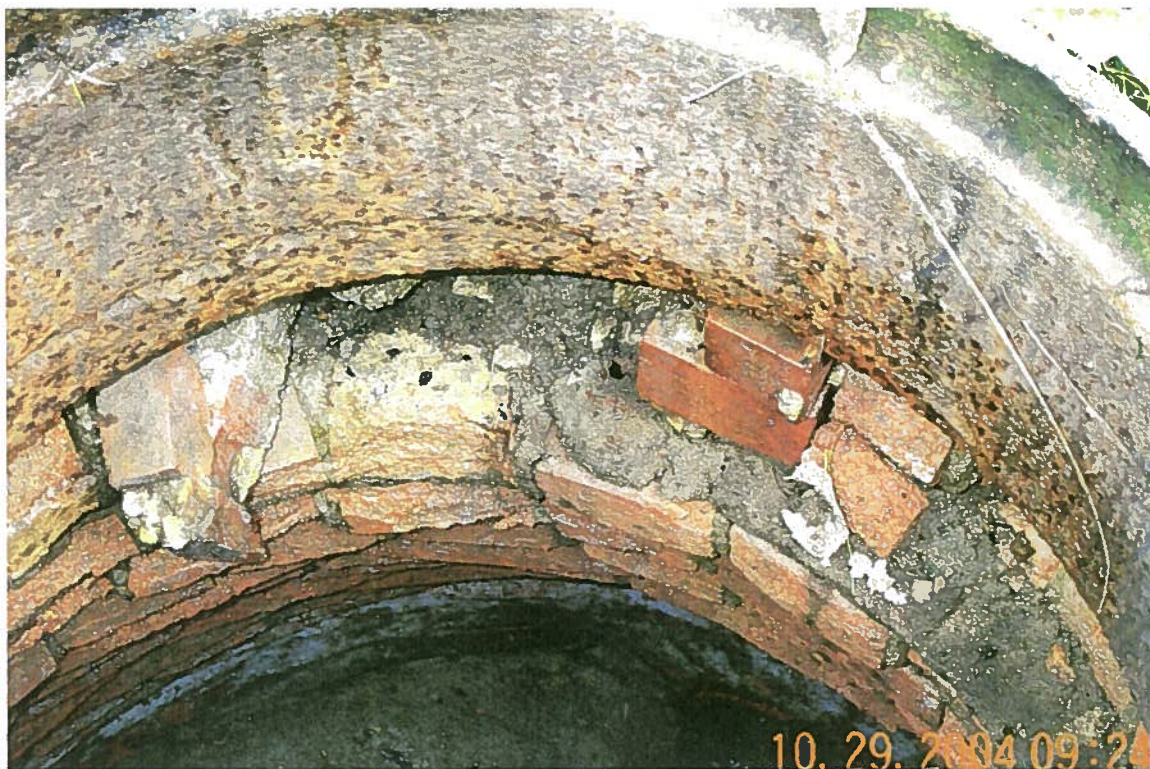
Manhole: 14-3

Defect: Grade Adjustment

Description: Severe grade adjustment defect. This manhole is located in a grassy median a few feet from a storm ditch.

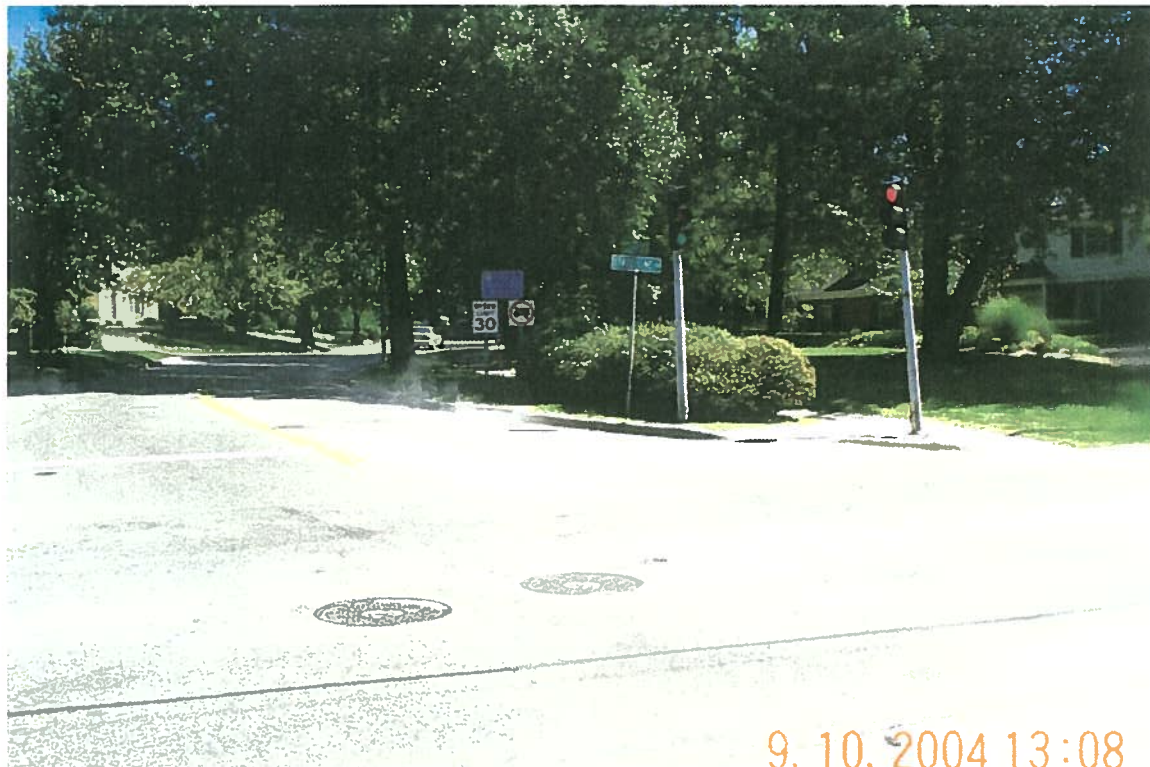
Segment: 17-1 to 17-2

Description:
Smoking Catch Basin.
Dyed-water test was
not completed because
the only hydrants
located nearby are on
KCMO water. The
dyed-water test results
are included in
Appendix C.

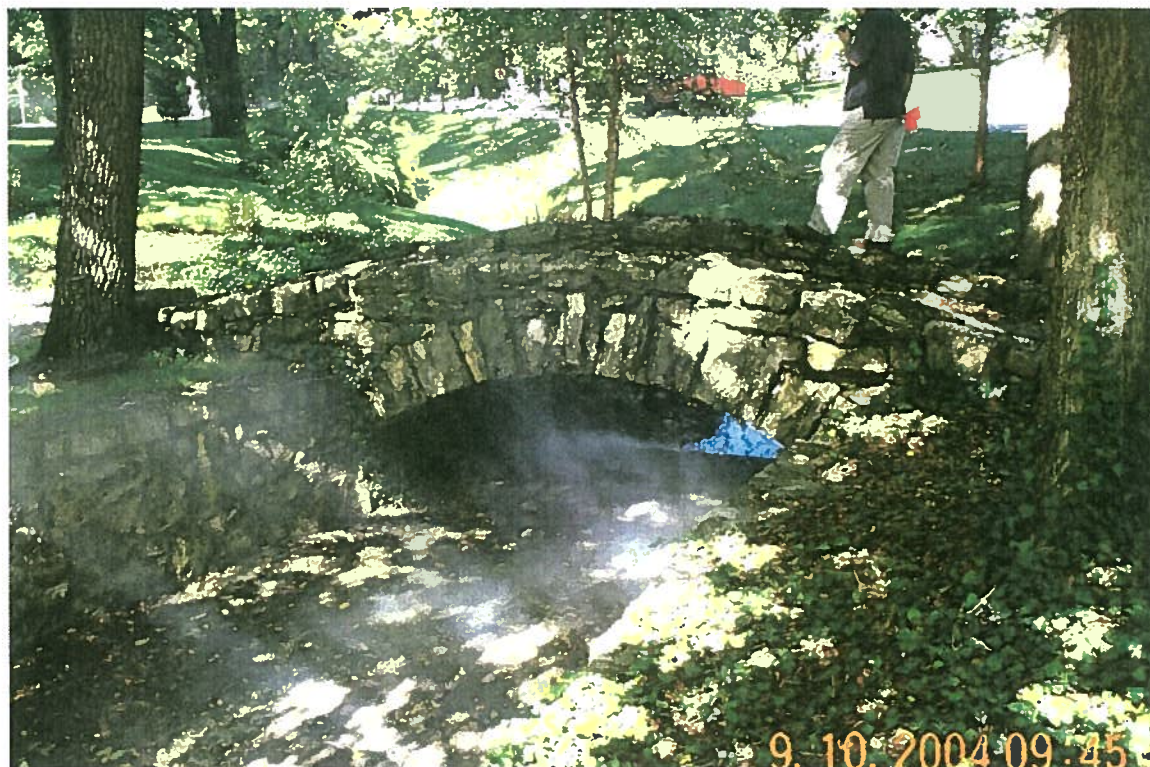
Segment: 14-3 to 18-5

Description: Heavy
smoke from storm
ditch. Indirect
connection with light
dye observed but
crews were unable to
simulate storm
conditions.

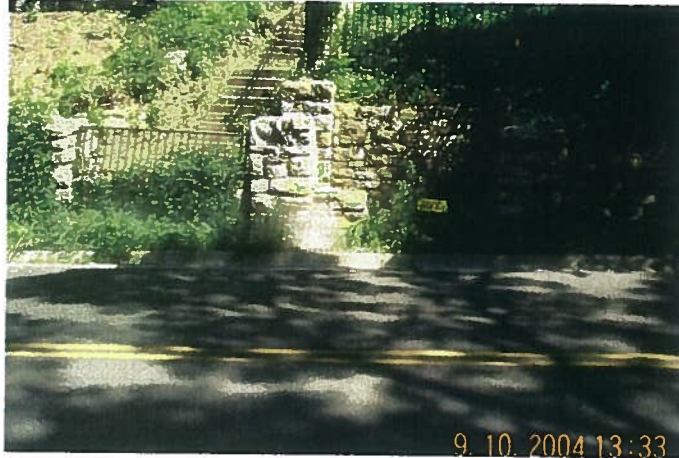
Line Segment and Location

The line segment 1-1 to 1-2 is located on State Line Rd running north towards Mission Dr.

Heavy smoke was observed coming from an area drain located at the back of curb on the east side of State Line Rd.

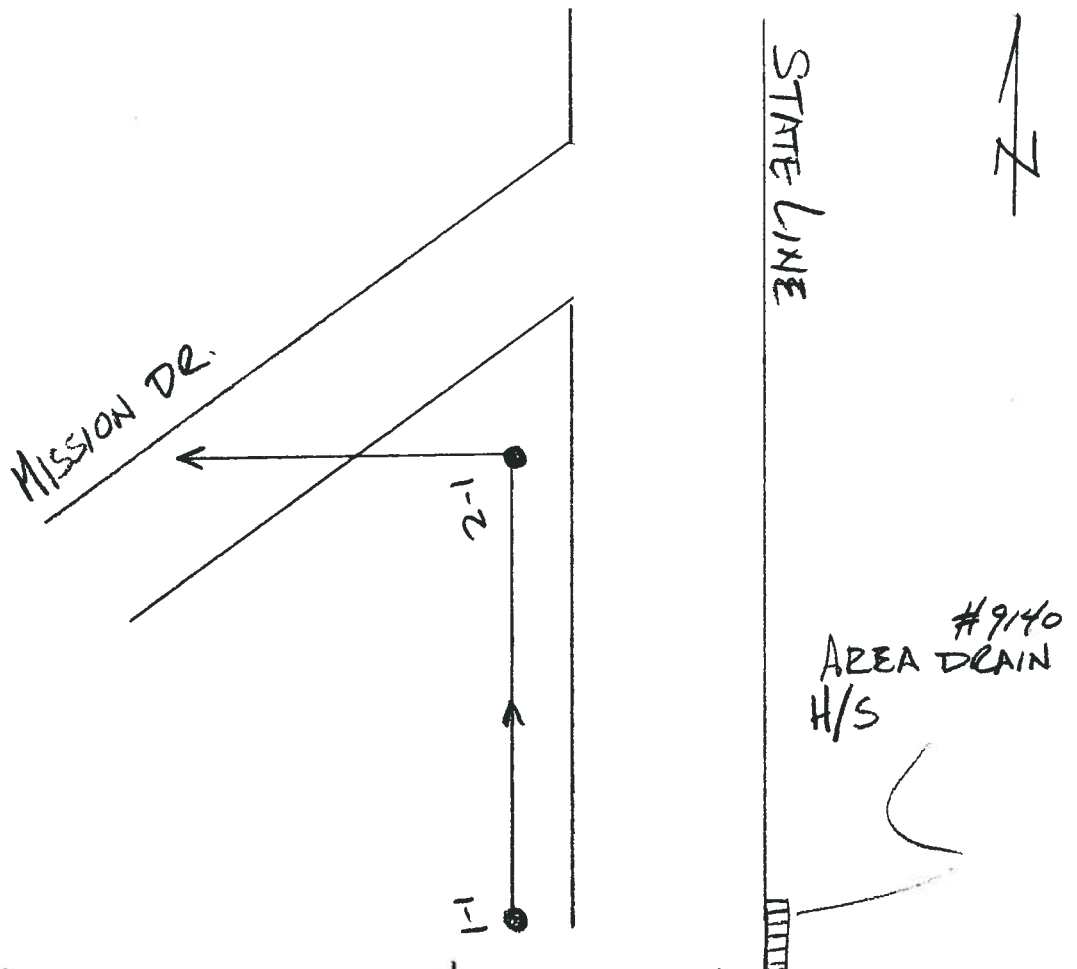
COMMENTS: POSSIBLE DIRECT CONNECT W/ SANITARY SEWER

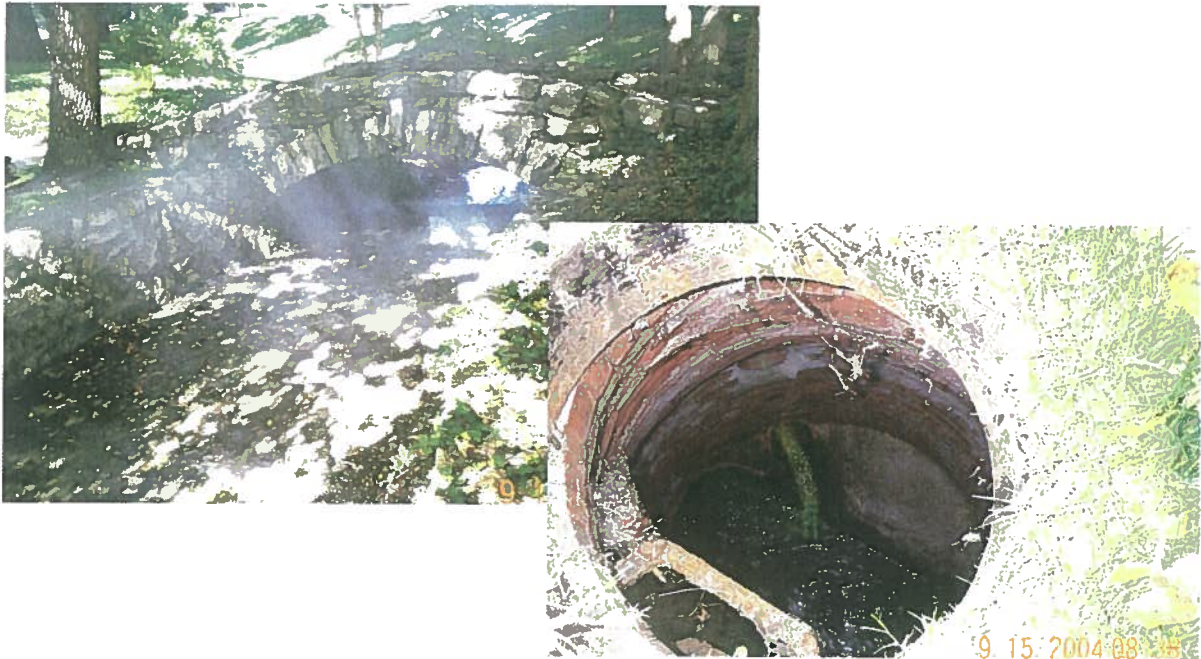
Line Segment and Location

The line segment 14-3 to 18-5 is located along Brookwood Rd. flowing to the southwest to Mission Dr.

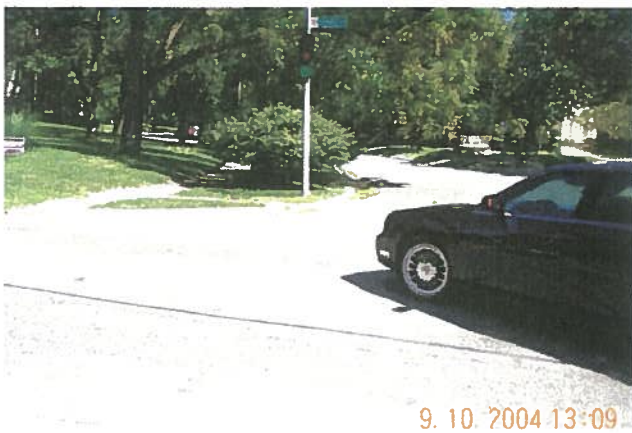
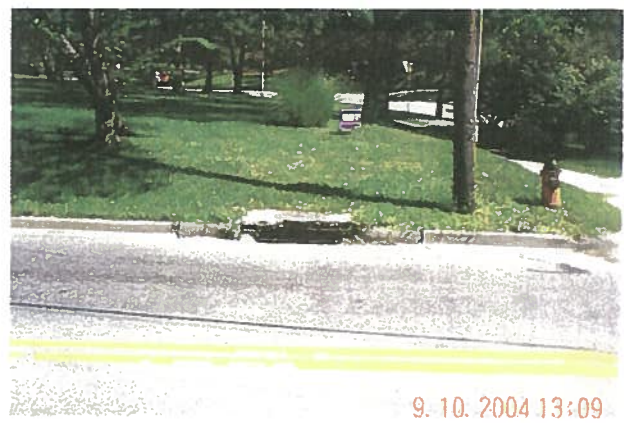
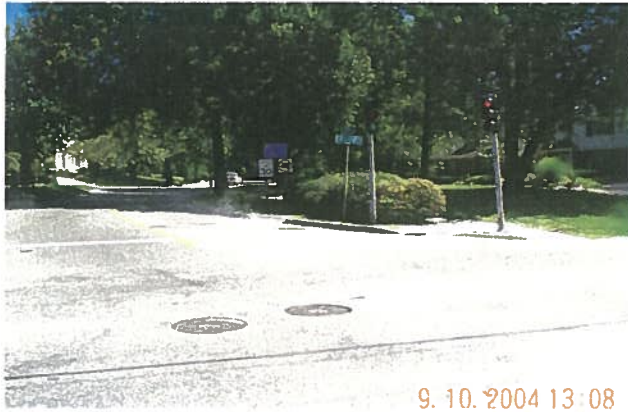
Line Segment and Location

Line Segment 17-1 to 17-2 is located along State Line Rd. running south to W. 63rd St.

This segment is recommended for dyed-water testing using the KCMO fire hydrant or other substantial water source along with traffic control along 63rd Street. Also, television inspection past the root blockage will be necessary for final design.
